NATIONAL DAM SAFETY PROGRAM. BLIND BROOK COUNTRY CLUB DAM (INVE--ETC(U)

AUG 81 E O'BRIEN

PHASE I INSPECTION REPORT  
NATIONAL DAM SAFETY PROGRAM  
BLIND BROOK DAM  
I.D. NO. N.Y. 123  
N.Y. D.E.C. NO. 232C-2747  
LONG ISLAND BASIN  
WESTCHESTER COUNTY, N.Y.

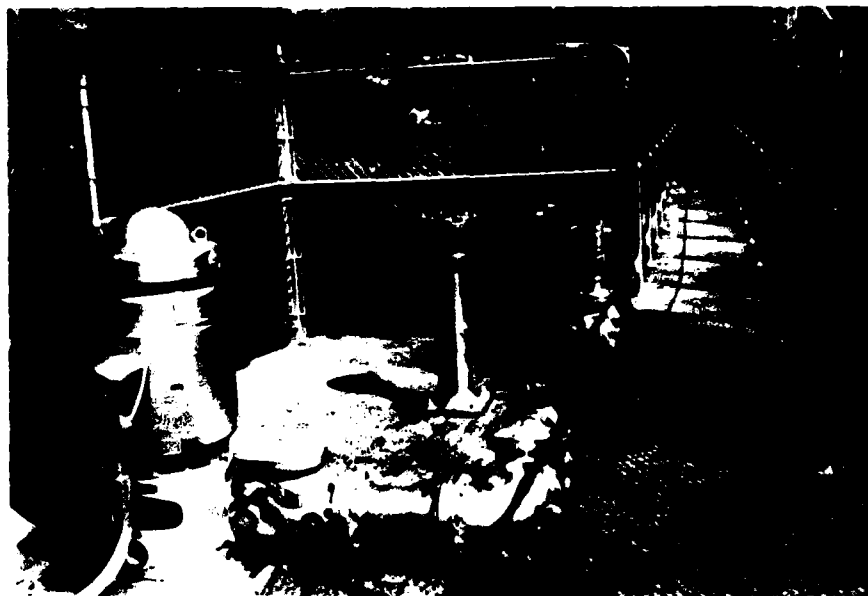
The gate valve for the reservoir drain was operated during the inspection. The lifting of the gate and discharge through the drain appeared normal. The crank wheel used to operate the valve is located at the Blind Brook Country Club Maintenance Shed. The pumping machinery and its supports appear to be in good condition (See PHOTOGRAPH 6).

PHOTOGRAPH 6. CONDITION OF CONCRETE AT CREST (OBSERVE  
GOOD CONDITION OF MACHINERY)

a. Description and Condition Machinery and piping  
equipment for irrigation of the golf course are  
located at the crest of the structure. This  
equipment is in excellent condition and is  
regularly maintained by Country Club personnel.
